Tornado Protection: Selecting and Designing Safe

Areas in Buildings.

TR-83B / DEFENSE CIVIL PREPAREDNESS AGENCY : APRIL 1976

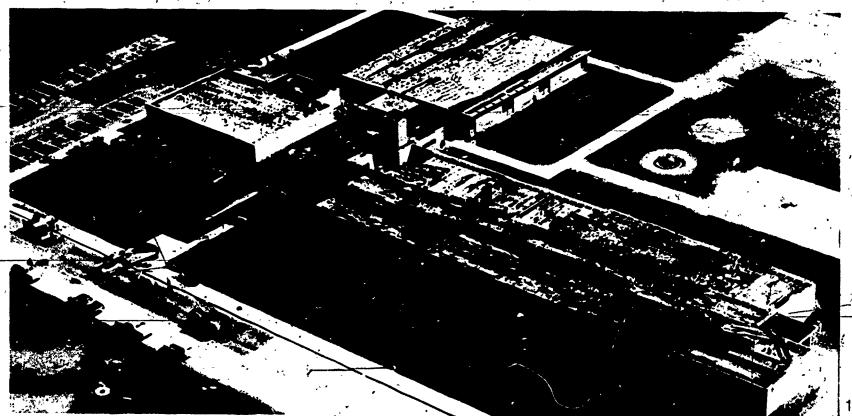
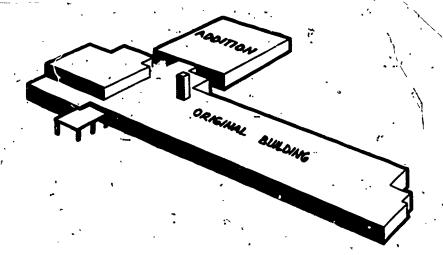
MEADOWLAWN ELEMENTARY SCHOOL

Unrepairable damage occurred to the original classroom wing when the south exterior walls failed. The WINDOWS blew into all of the WINDWARD SIDE classrooms. All south and west windows were broken. Wind entering these rooms caused a ballconing effect. Some of the metal roof deck was lifted, and was scattered through an open field northeast of the school.

The original 12 classrooms and library were demolished. The boiler room, multipurpose room, offices, and the $six_{\bar{z}}$ classroom addition were-repairable.

North and east classrooms received little damage.

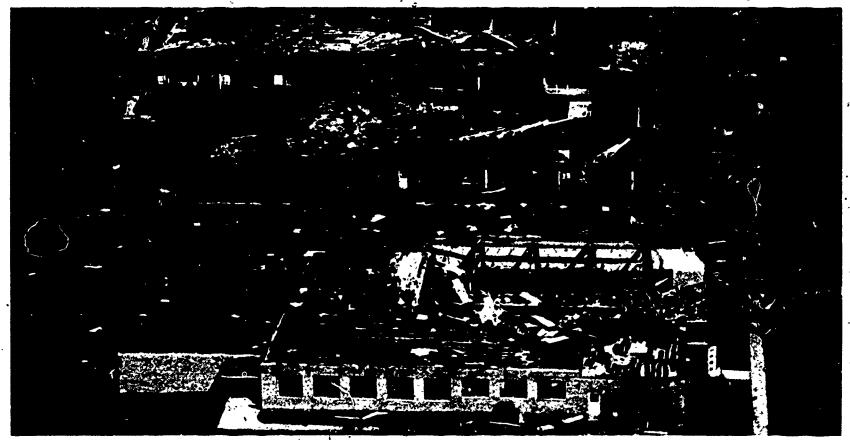
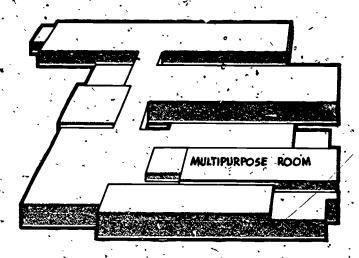
MONROE CENTRAL SCHOOL PARKER, INDIANA

The tornado center passed slightly to the right of the center of the building, and caused major damage to all three wings. The inclosure walls failed, allowing the winds to enter interior spaces, lift roofs, and toss debris throughout the building.

Winds entering the room caused a ballooning effect. The lightweight roof deck was blown off. Some of the deck and the steel bulb tees fell on the floor; and the remainder blew onto adjacent roofs and open spaces:

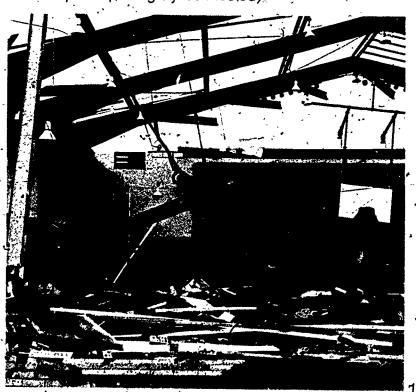
The winds blew into the building from the south and east. The WINDWARD (east) GLASS CURTAIN WALLS blew in, prick, gravel, and block. This was particularly true of the allowing a ballooning effect, which caused the LOAD-BEARING end walls to blow out. The precast concrete roof planks were lifted up. Some fell back into the rooms, and others blew on top of the remaining roof. The north-south corridors became WIND TUNNELS throughout their entire length.

The completely INTERIOR SPACES remained intact, offering protection against incoming missiles such as glass, SHORT SPANS or smaller spaces such as toilet rooms, work rooms, and storage spaces. Rooms on the leeward (north) side received least damage. Only one north window was broken. The STRUCTURAL FRAME remained intact. However, the roof deck was not rigidly connected to these frames, and for the most part depended upon their weight to resist wind uplift. The HEAVY CONCRETE ROOF remained intact over most of the building.

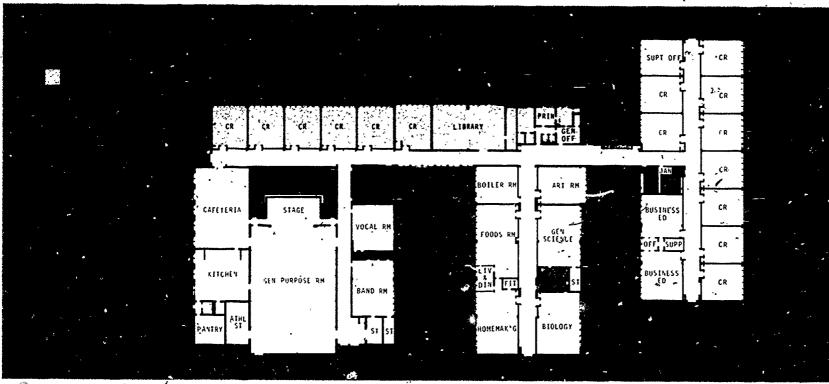
XENIA SENIOR HIGH SCHOOL XENIA, OHIO

The tornado passed directly over the school. Two school buses came to rest on the stage where the students had been rehearing. Some of the students were treated at a nearby hospital for injuries.

The building was unsafe to enter and was demolished.
